Jumper FIX for AR2FS board February 9, 2005

Instructions for the installation of a jumper to repair bad via contact at Location #10 on ASDBLR side of board.

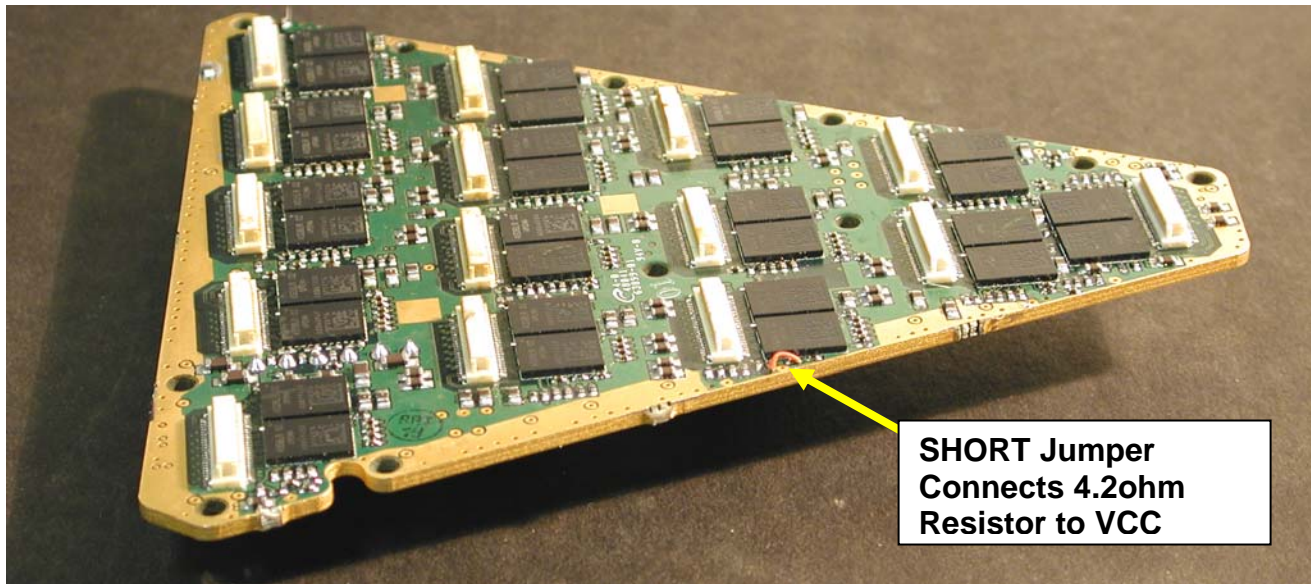
A mistake in the layout of the AR2FS board prevents the 4.7ohm preamp resistor at location #10 (DTMROC side silk screen numbering) from connecting to the Vcc supply. This is easily corrected by soldering a jumper to a nearby location. The jumper should connect between a trace that supplies +3V to an 18k resistor and a 0.1uF capacitor (See Gerber View below) and a 4.7ohm resistor as shown. It should be rated to carry at least 20mA current. For mechanical reasons we suggest 28AWG wire.

The picture above shows the location of the Jumper on the AR2FS board.

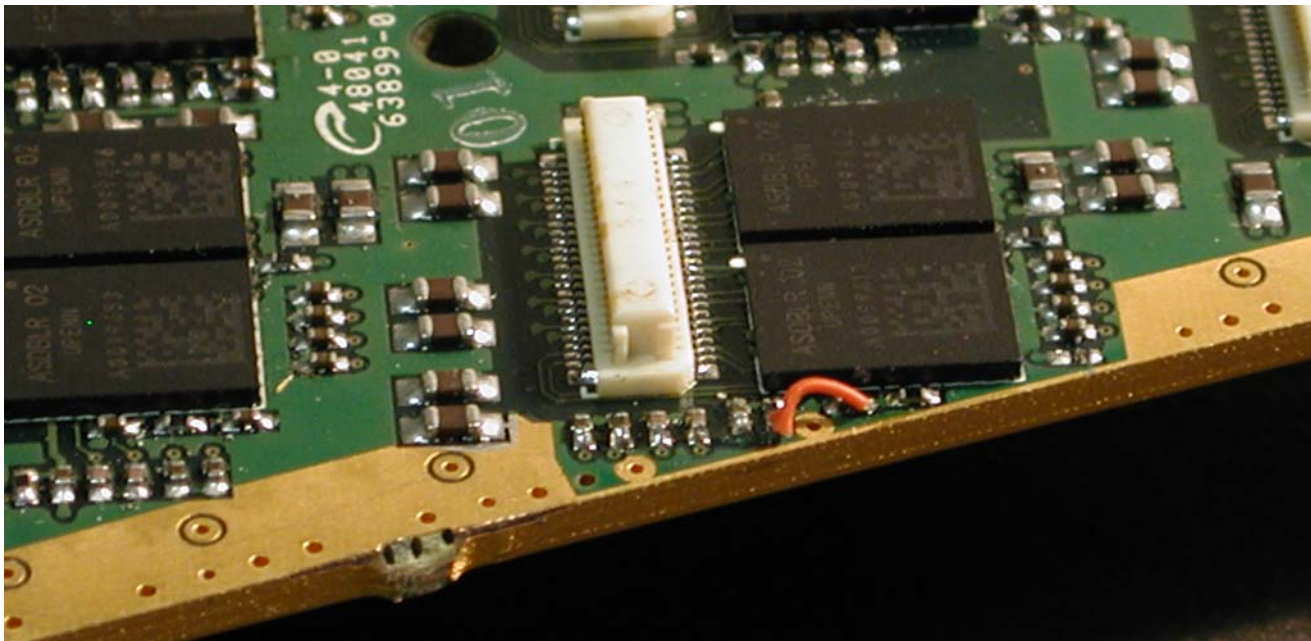
Closeup view of installed jumper. Note jumper attaches to 4.7ohm resistor on contact away from the ASDBLR chip, towards perimeter of board.

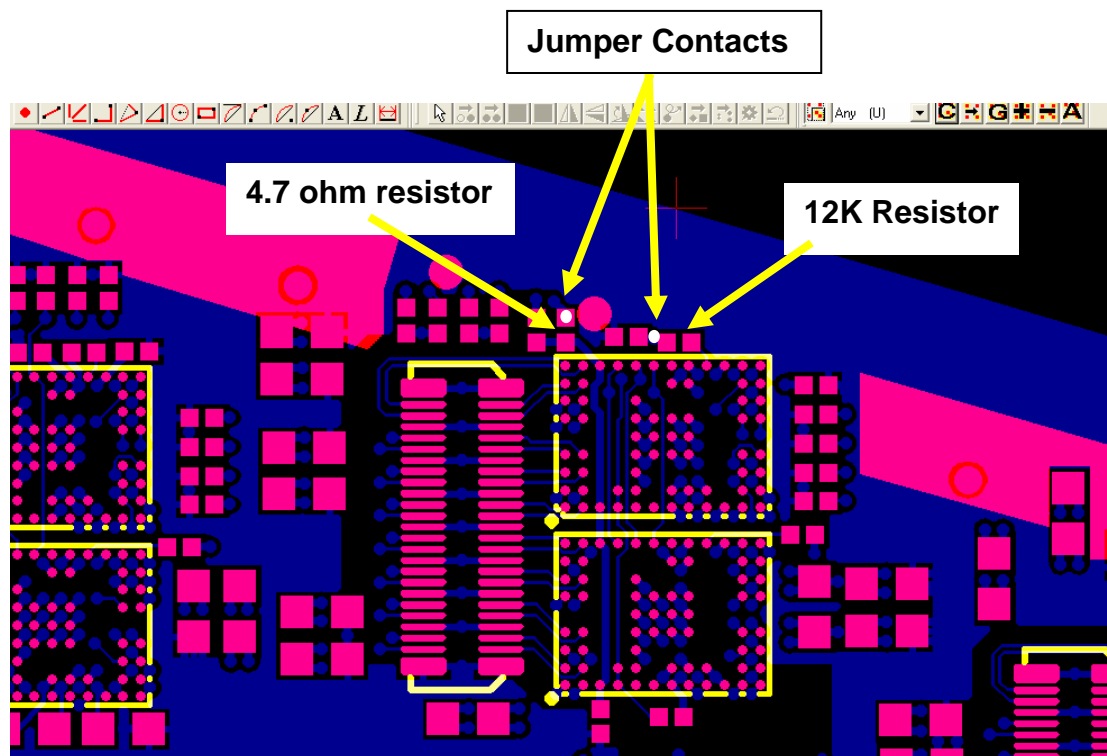
This gerber view with the bottom layer and solder mask “on” shows the jumper contact points. White dots indicate the intended contacts. The junction contact on the right connects to Vcc between a .1uF cap and to a 12K resistor. The junction contact on the left goes to a 4.7ohm resistor.
