Jumper FIX for AR2FS board February 9, 2005

Instructions for the installation of a jumper to repair bad via contact at Location #10 on ASDBLR side of board.

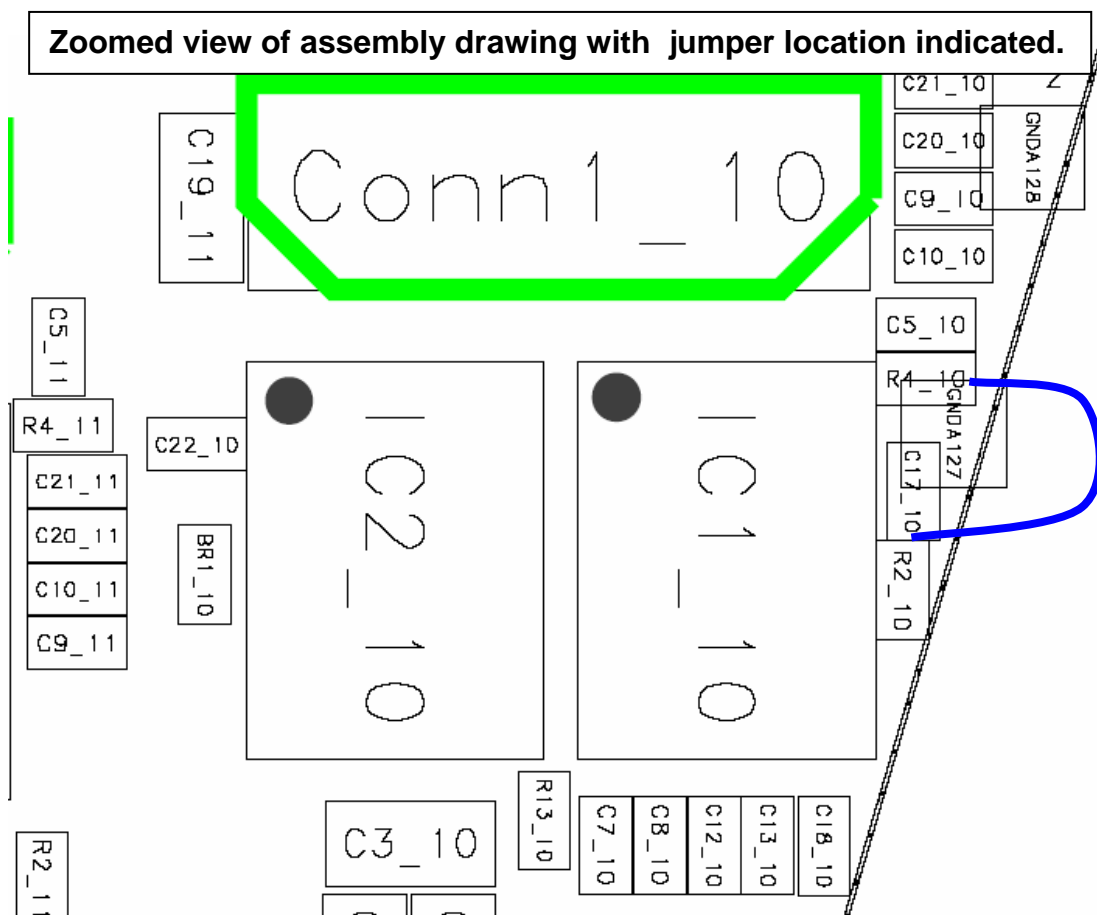
This gerber view with the bottom layer and solder mask “on” shows the jumper contact points. White dots indicate the intended contacts. The junction contact on the right connects to Vcc between a .1uF cap and to a 12K resistor. The junction contact on the left goes to a 4.7ohm resistor.
